Subject: Trip Report for Marine Shale

1. I conducted a corrective action site inspection at the Marine Shale Facility near Amelia, LA, beginning Thursday, April 30, 2009. I was accompanied by Vicky Hadwin from Louisiana Department of Environmental Quality (LDEQ). The purpose of the inspection was to support the LDEQ in the project management of a Department of Justice (DOJ) Consent Decree.

Official Photograph Log

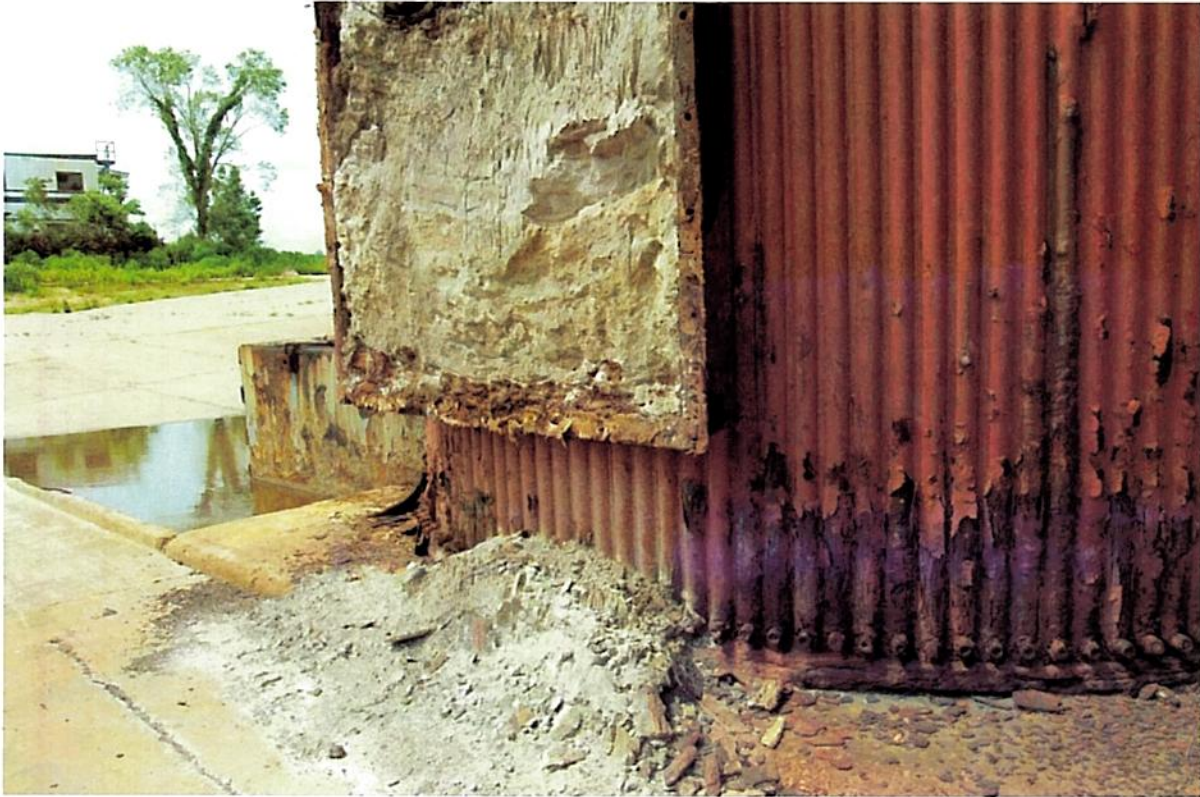
Photographer: C Barnes	Date: 4-30-09	Time: 0900 to 1300
City/County: Amelia,		State: LA
Location: Marine Shale Facility		
Subject: Multiple portions of the facility. Ash hopper at base of incinerator bag house

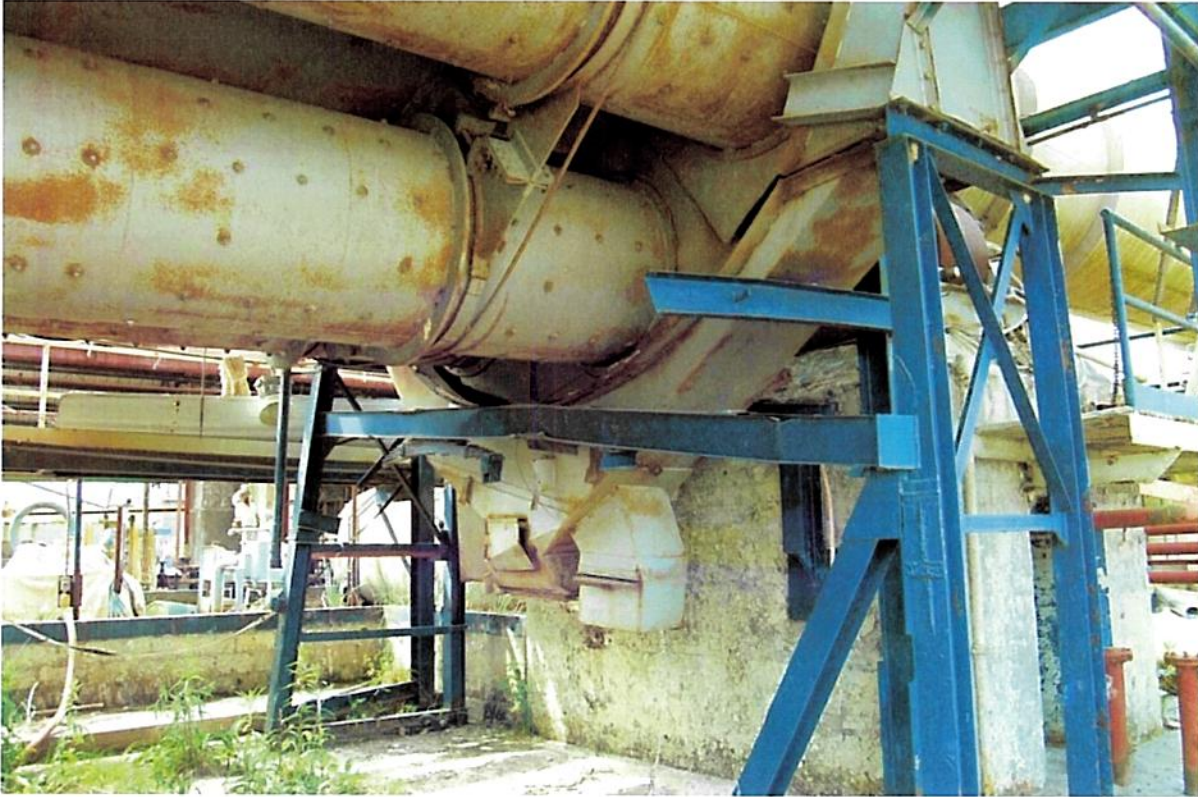
Photographer: C Barnes	Date: 4-30-09	Time: 0900 to 1300
City/County: Amelia,		State: LA
Location: Marine Shale Facility		
Subject: Multiple portions of the facility. Support structures for rotary kiln

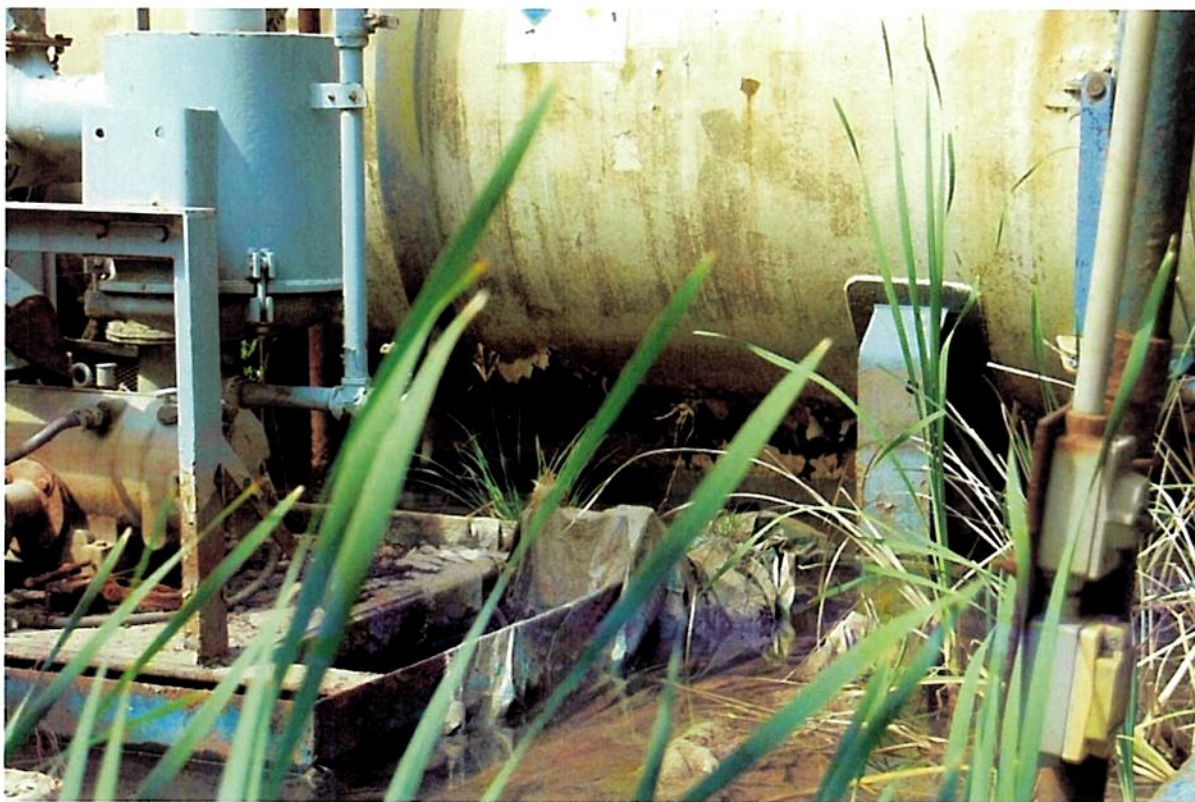
Photographer: C Barnes	Date: 4-30-09	Time: 0900 to 1300
City/County: Amelia,		State: LA
Location: Marine Shale Facility		
Subject: Multiple portions of the facility. Standing water inside secondary containment

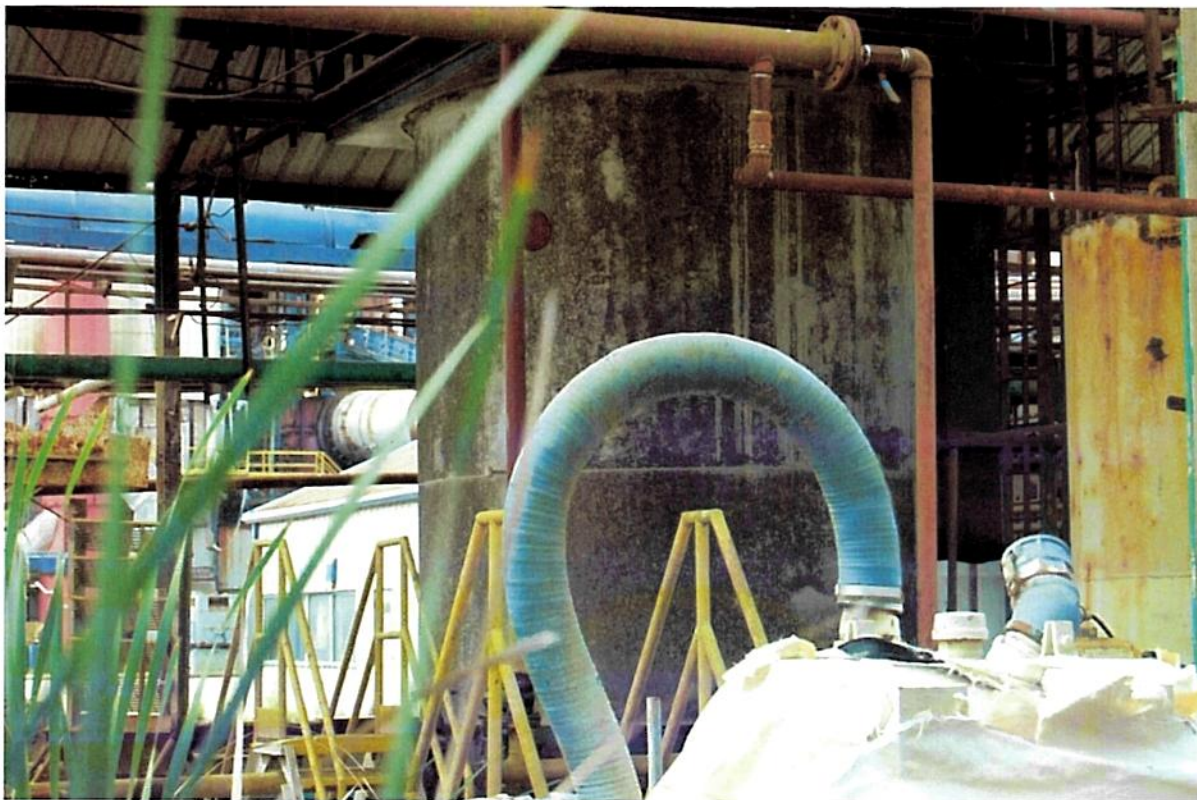
Photographer: C Barnes	Date: 4-30-09	Time: 0900 to 1300
City/County: Amelia,		State: LA
Location: Marine Shale Facility		
Subject: Multiple portions of the facility. Tankage related to rotary kiln

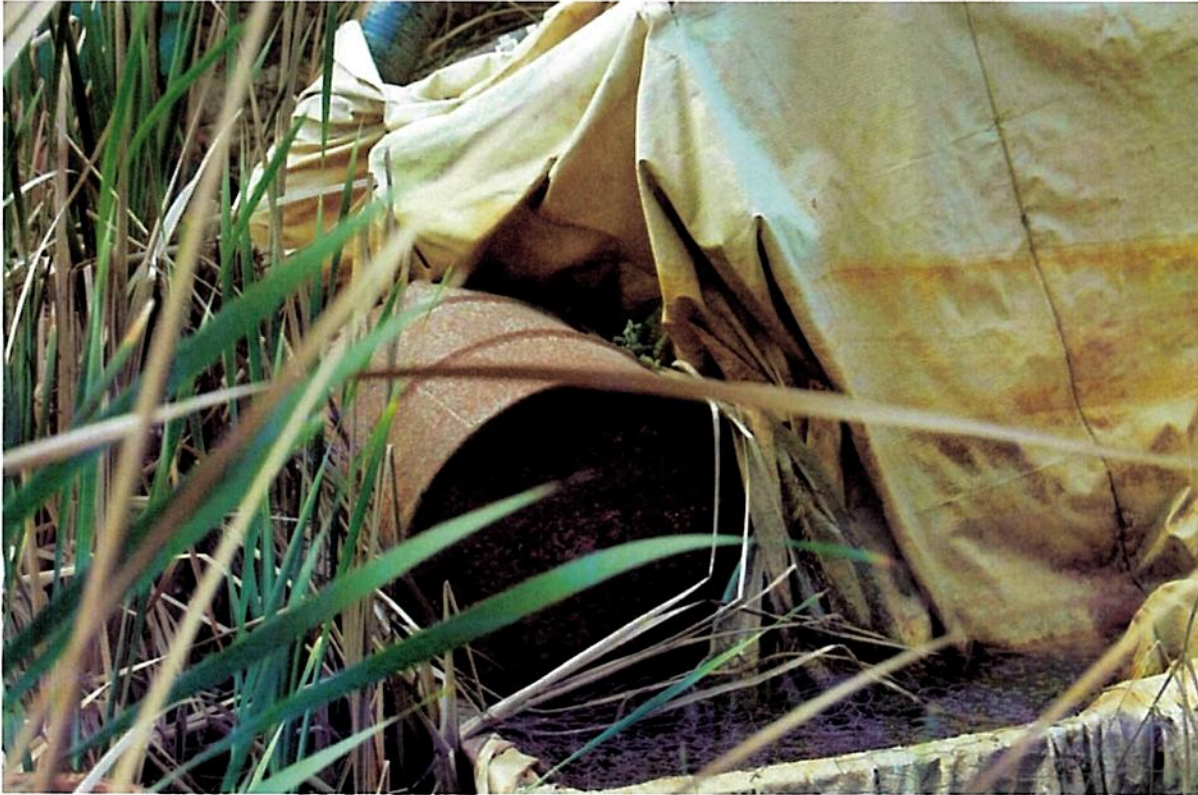
Photographer: C Barnes	Date: 4-30-09	Time: 0900 to 1300
City/County: Amelia,		State: LA
Location: Marine Shale Facility		
Subject: Multiple portions of the facility. Rusted drum inside secondary containment area. Note cattails growing inside containment area.

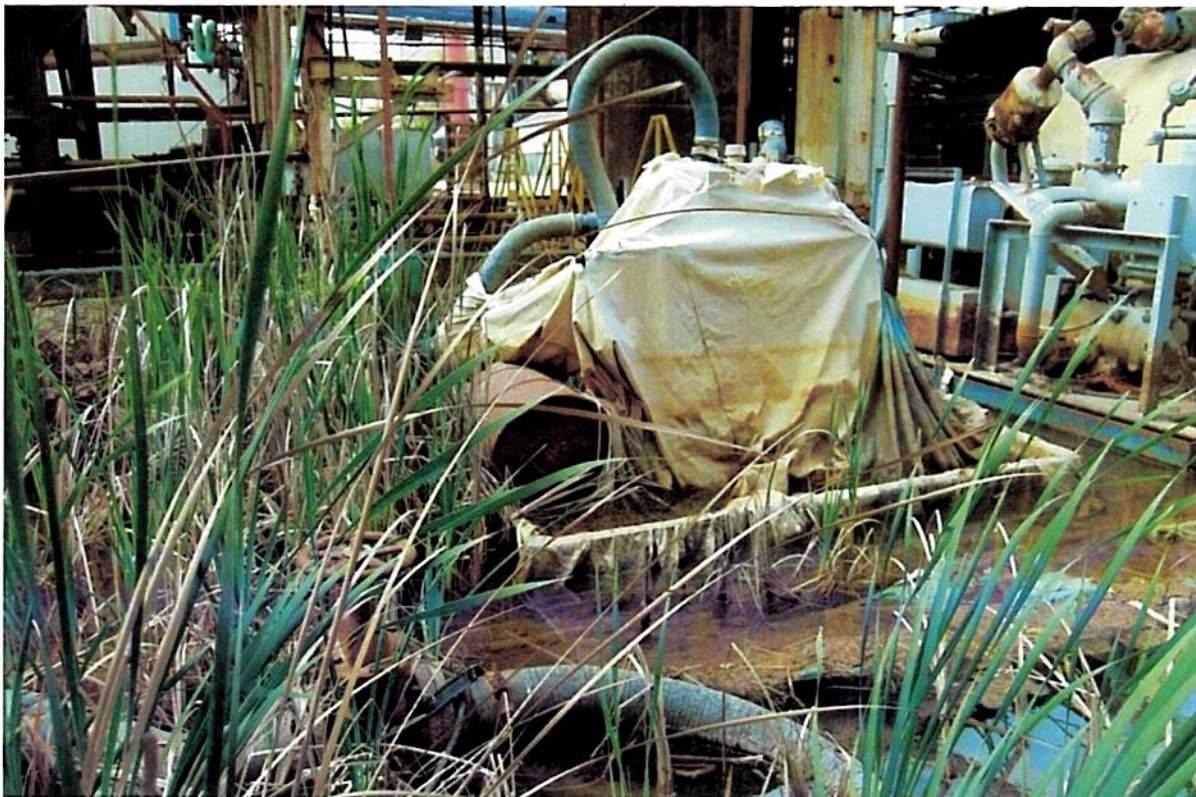
Photographer: C Barnes	Date: 4-30-09	Time: 0900 to 1300
City/County: Amelia,		State: LA
Location: Marine Shale Facility		
Subject: Multiple portions of the facility. Broader view of preceding photograph

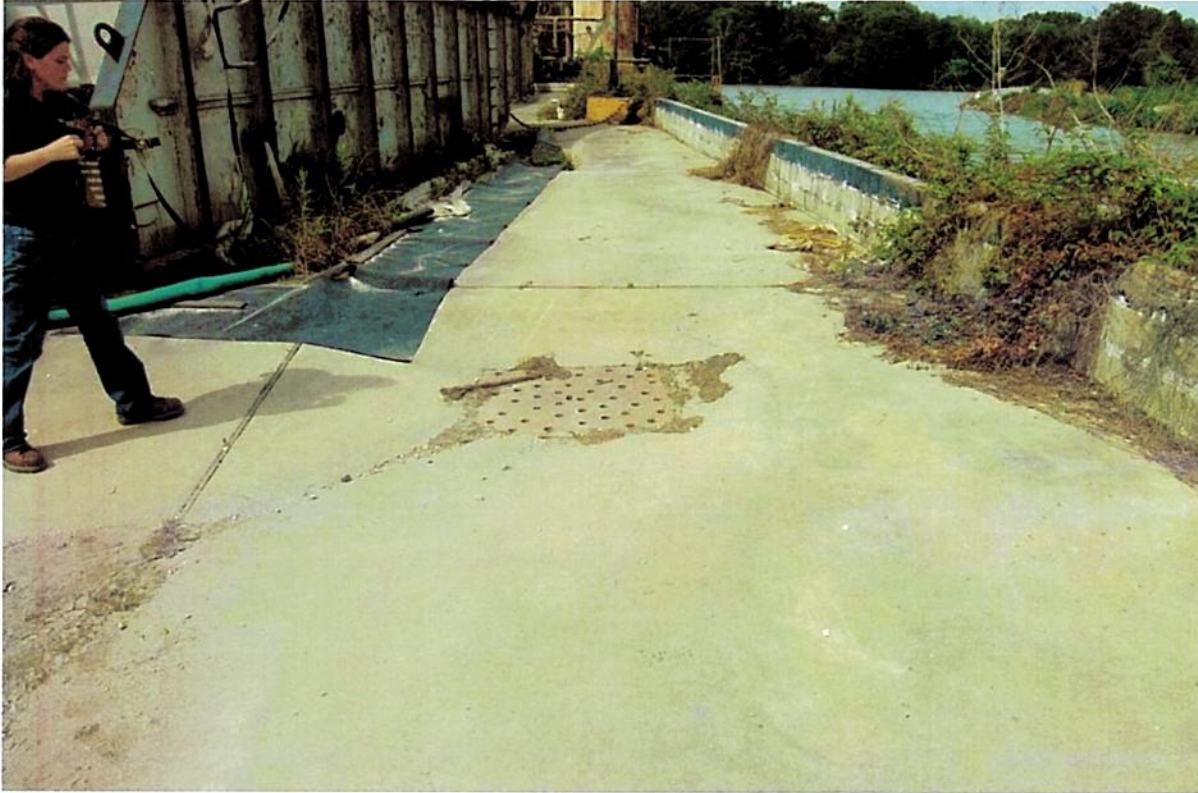
Photographer: C Barnes	Date: 4-30-09	Time: 0900 to 1300
City/County: Amelia,		State: LA
Location: Marine Shale Facility		
Subject: Multiple portions of the facility. Storm drain adjacent to barge slip

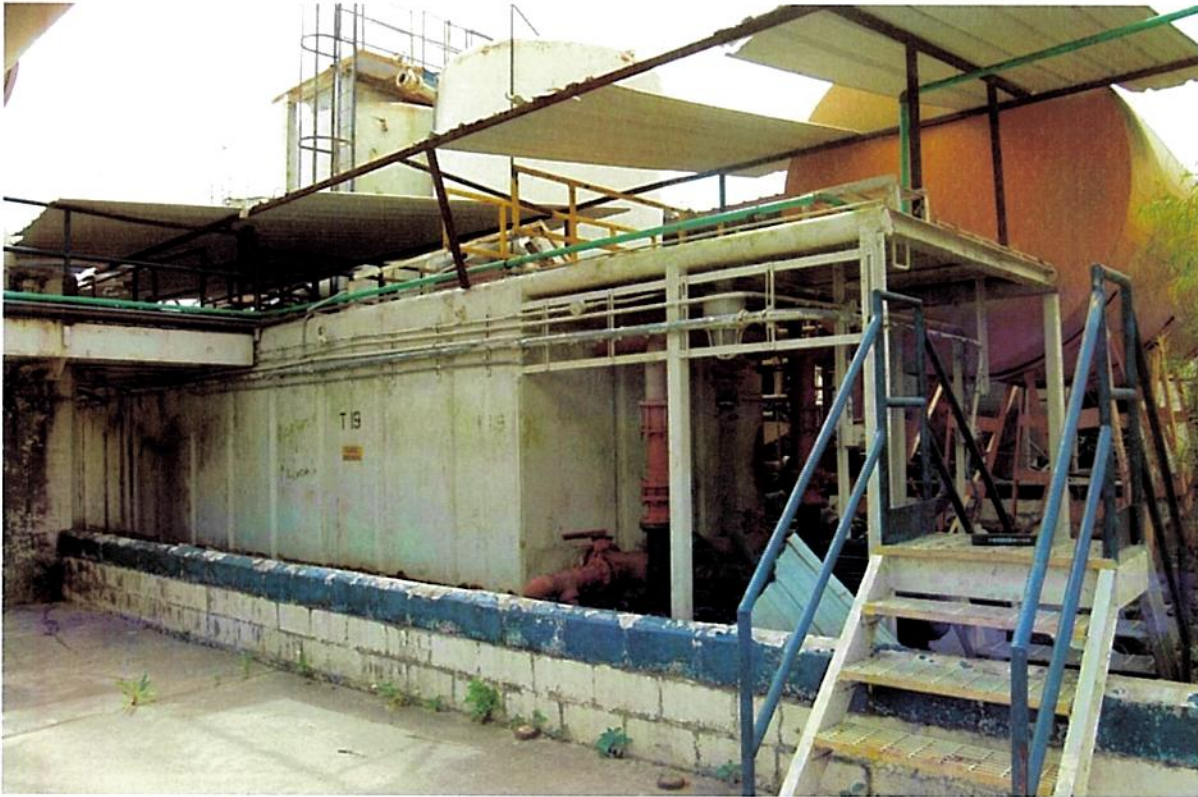
Photographer: C Barnes	Date: 4-30-09	Time: 0900 to 1300
City/County: Amelia,		State: LA
Location: Marine Shale Facility		
Subject: Multiple portions of the facility. Bulk tanks associated with incinerators operations

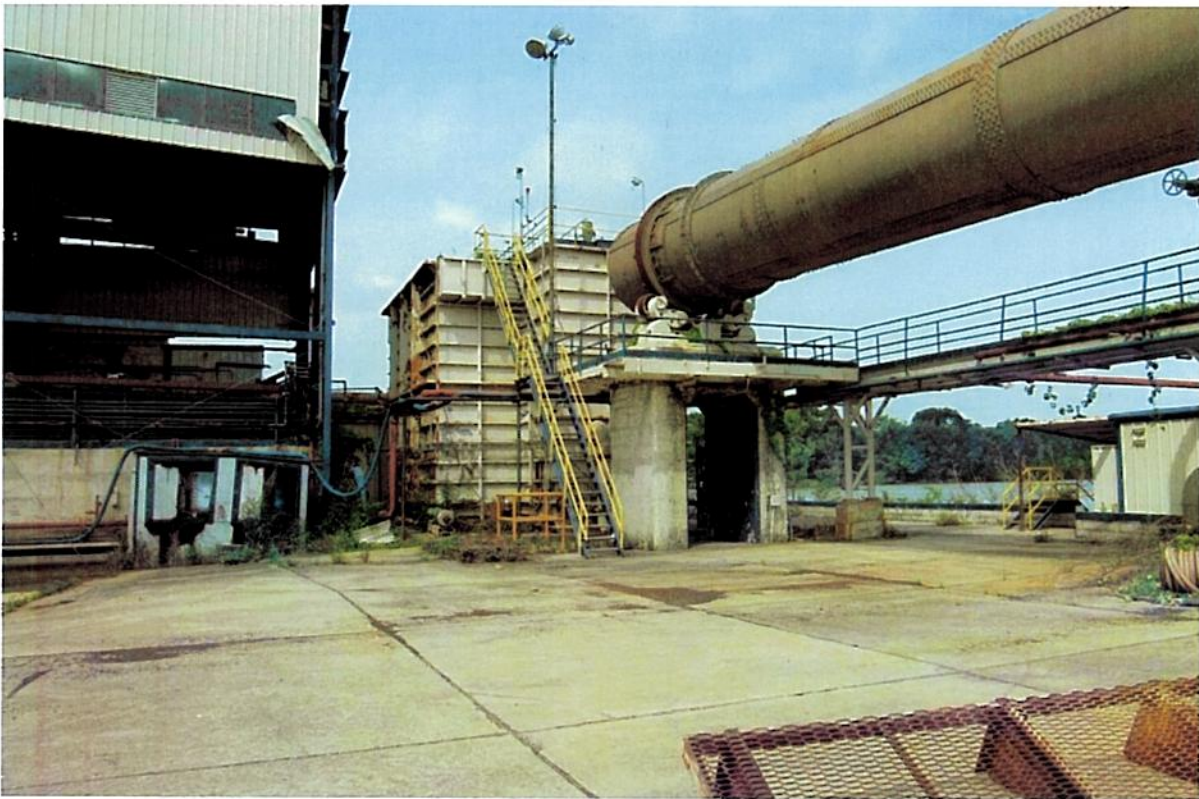
Photographer: C Barnes	Date: 4-30-09	Time: 0900 to 1300
City/County: Amelia,		State: LA
Location: Marine Shale Facility		
Subject: Multiple portions of the facility. Rotary kiln and associated bulk storage processing facilities

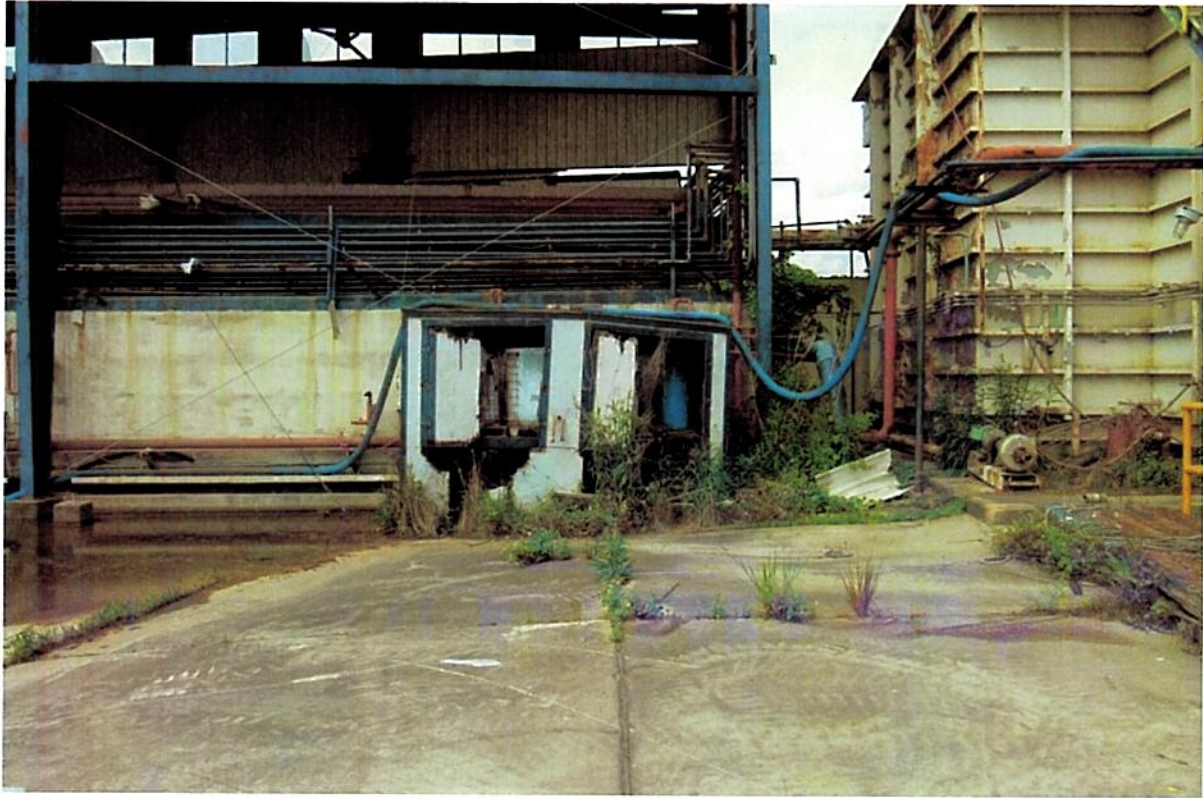
Photographer: C Barnes	Date: 4-30-09	Time: 0900 to 1300
City/County: Amelia,		State: LA
Location: Marine Shale Facility		
Subject: Multiple portions of the facility. Bulk material processing facilities. Note standing water at lower left of photograph

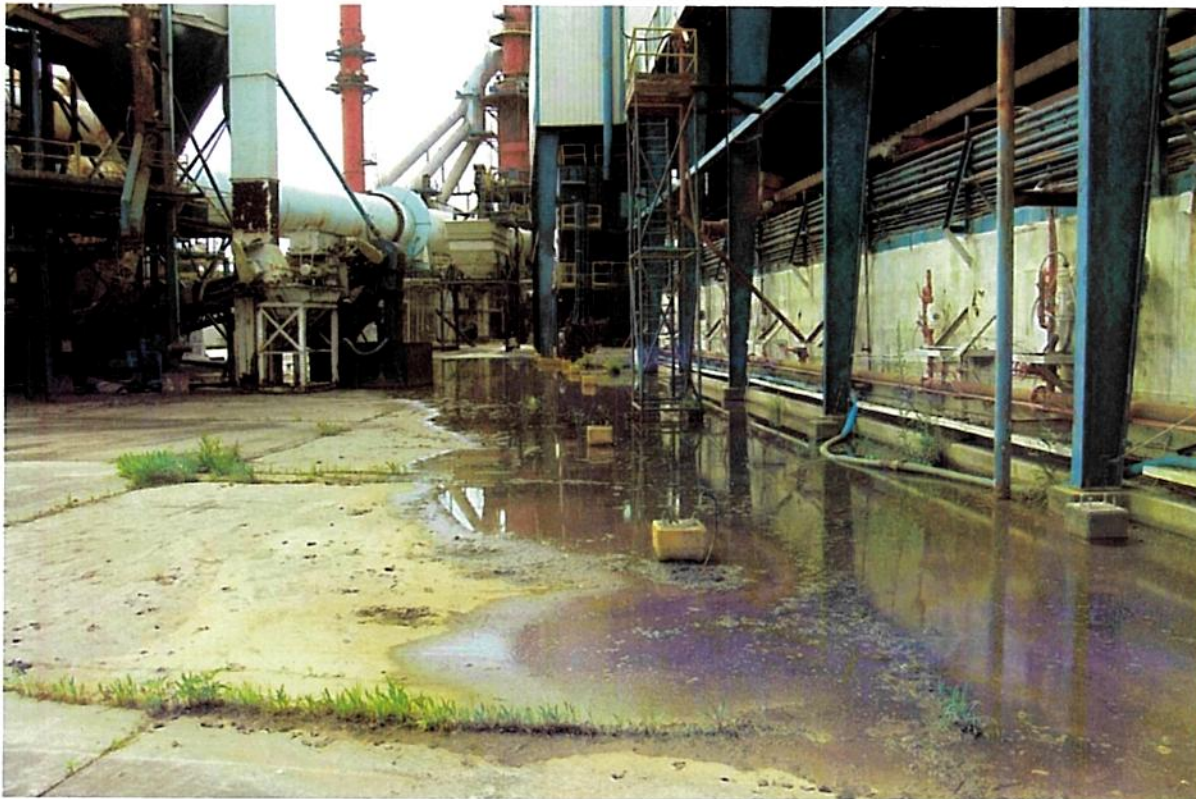
Photographer: C Barnes	Date: 4-30-09	Time: 0900 to 1300
City/County: Amelia,		State: LA
Location: Marine Shale Facility		
Subject: Multiple portions of the facility. Broad view of rotary kiln, bulk material processing area and standing waters.

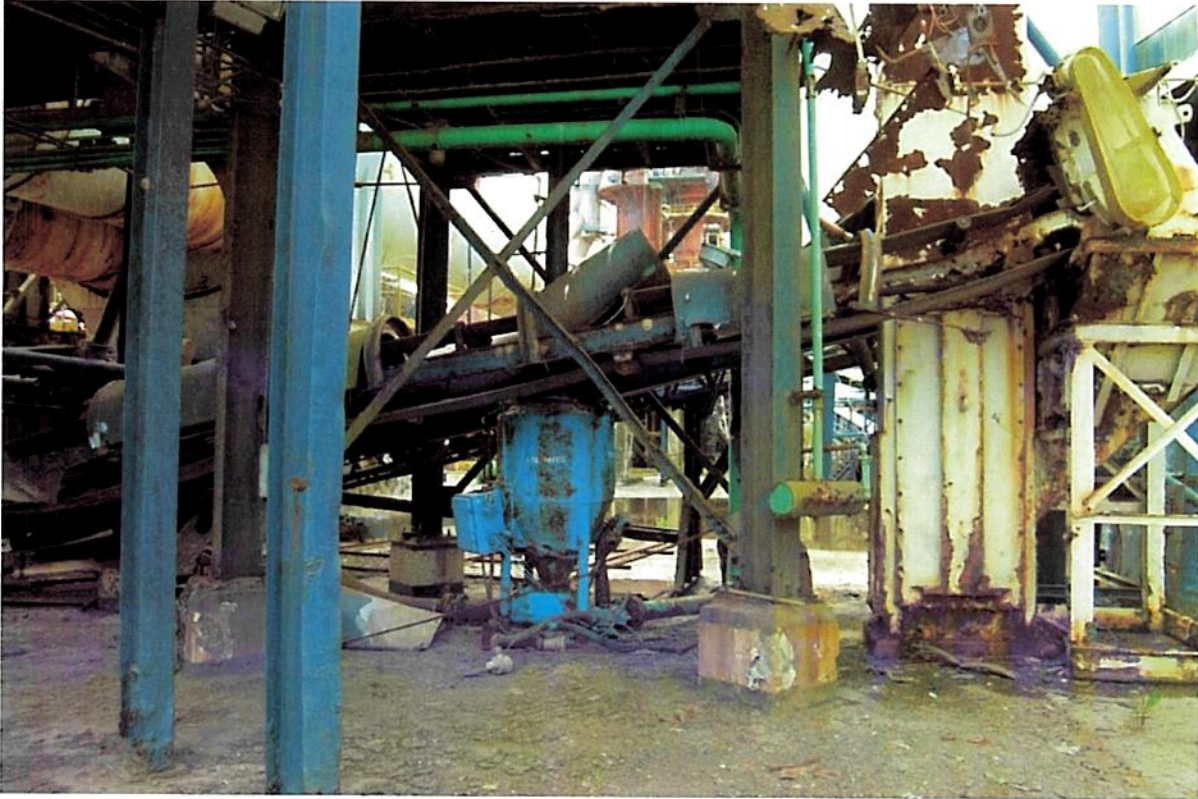
Photographer: C Barnes	Date: 4-30-09	Time: 0900 to 1300
City/County: Amelia,		State: LA
Location: Marine Shale Facility		
Subject: Multiple portions of the facility. Bulk/dry material handling equipment. Note corrosion

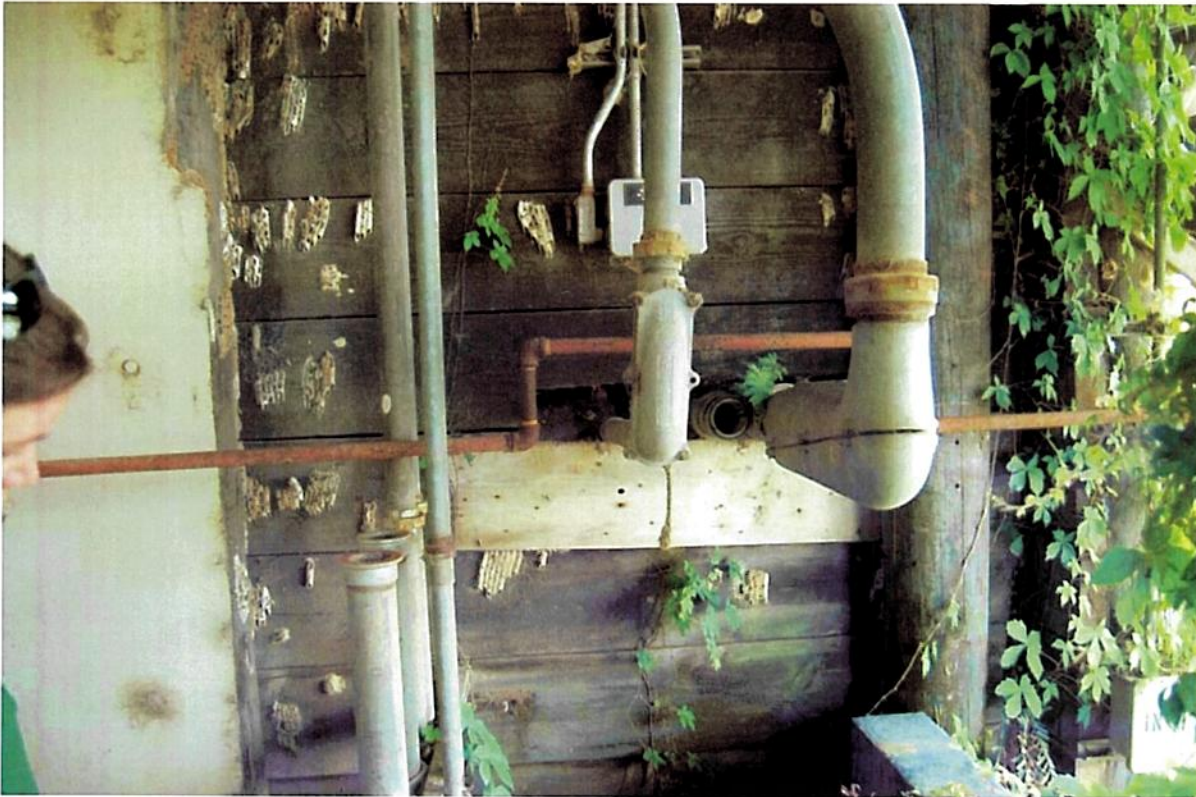
Photographer: C Barnes	Date: 4-30-09	Time: 0900 to 1300
City/County: Amelia,		State: LA
Location: Marine Shale Facility		
Subject: Multiple portions of the facility. Electrical conduit. Copper wire has reportedly been stolen from the facility

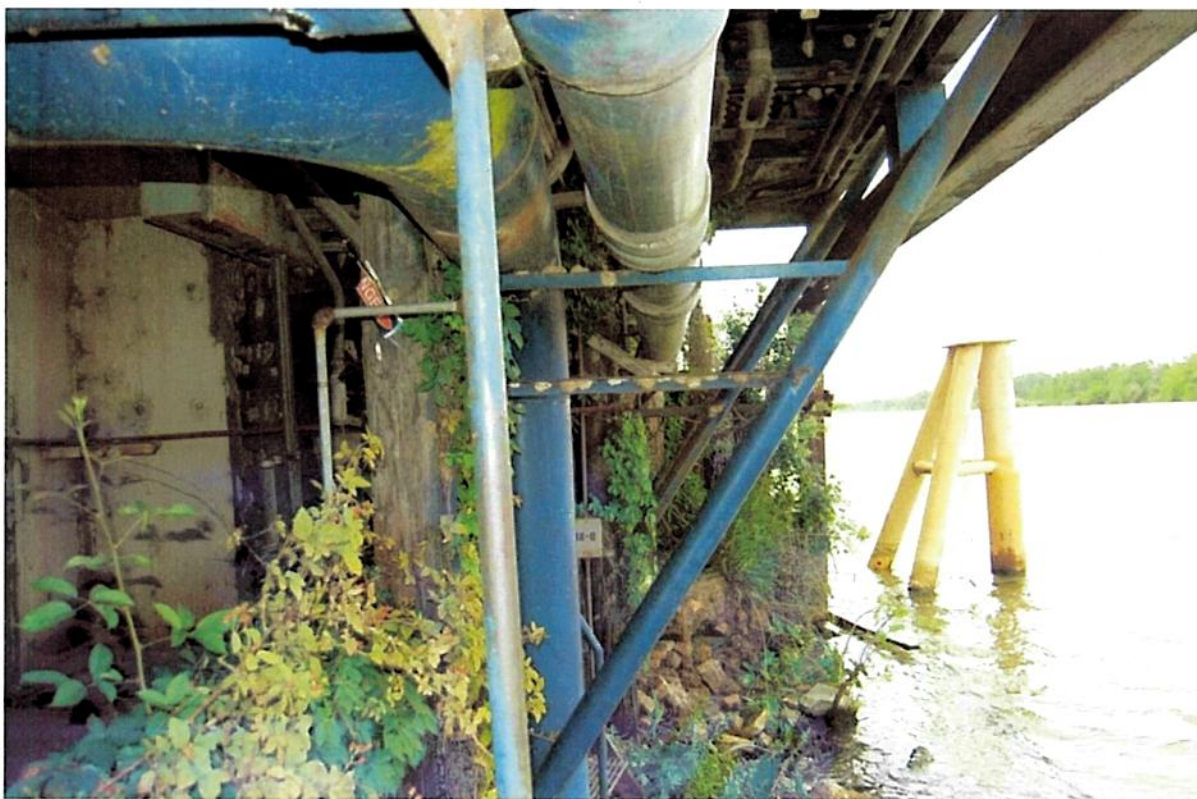
Photographer: C Barnes	Date: 4-30-09	Time: 0900 to 1300
City/County: Amelia,		State: LA
Location: Marine Shale Facility		
Subject: Multiple portions of the facility. Support pilings and barge tie up along canal

- c. Barge slip – metals, PCBs, organics
 - d. Refractory bricks – metals, radiation
 - e. Creosote pad – organics, metals, volatiles, semi-volatiles, etc.

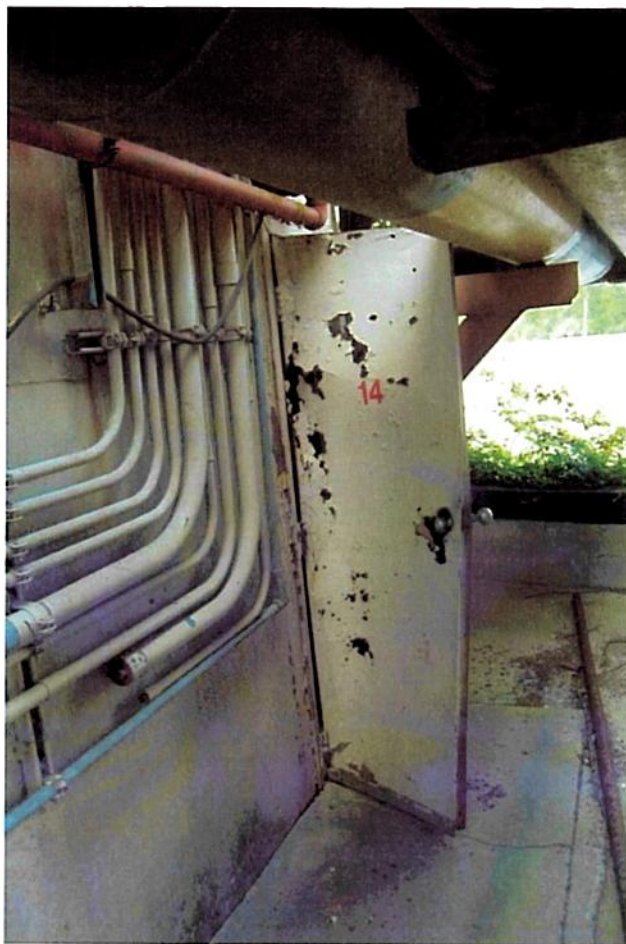
Photographer: C Barnes	Date: 4-30-09	Time: 0900 to 1300
City/County: Amelia,		State: LA
Location: Marine Shale Facility		
Subject: Multiple portions of the facility. Storm damage to doors & facility equipment

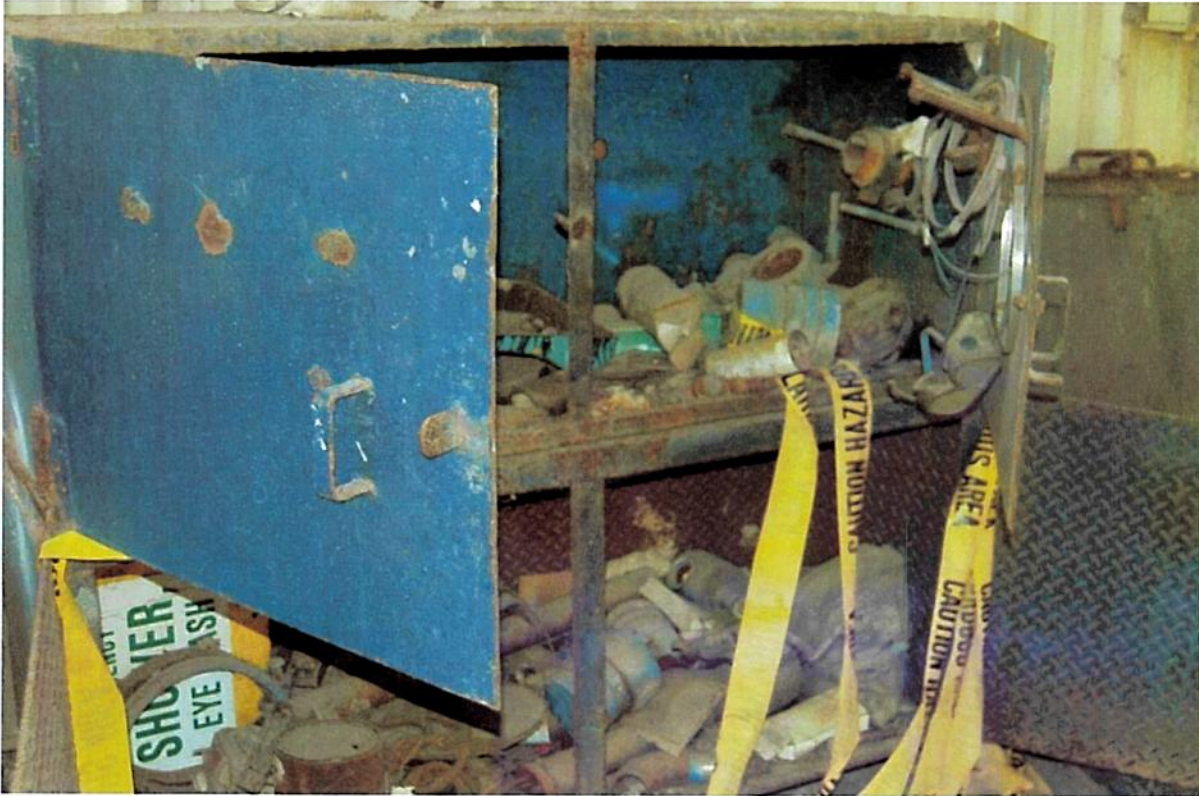
Photographer: C Barnes	Date: 4-30-09	Time: 0900 to 1300
City/County: Amelia,		State: LA
Location: Marine Shale Facility		
Subject: Multiple portions of the facility. Operational equipment storage area

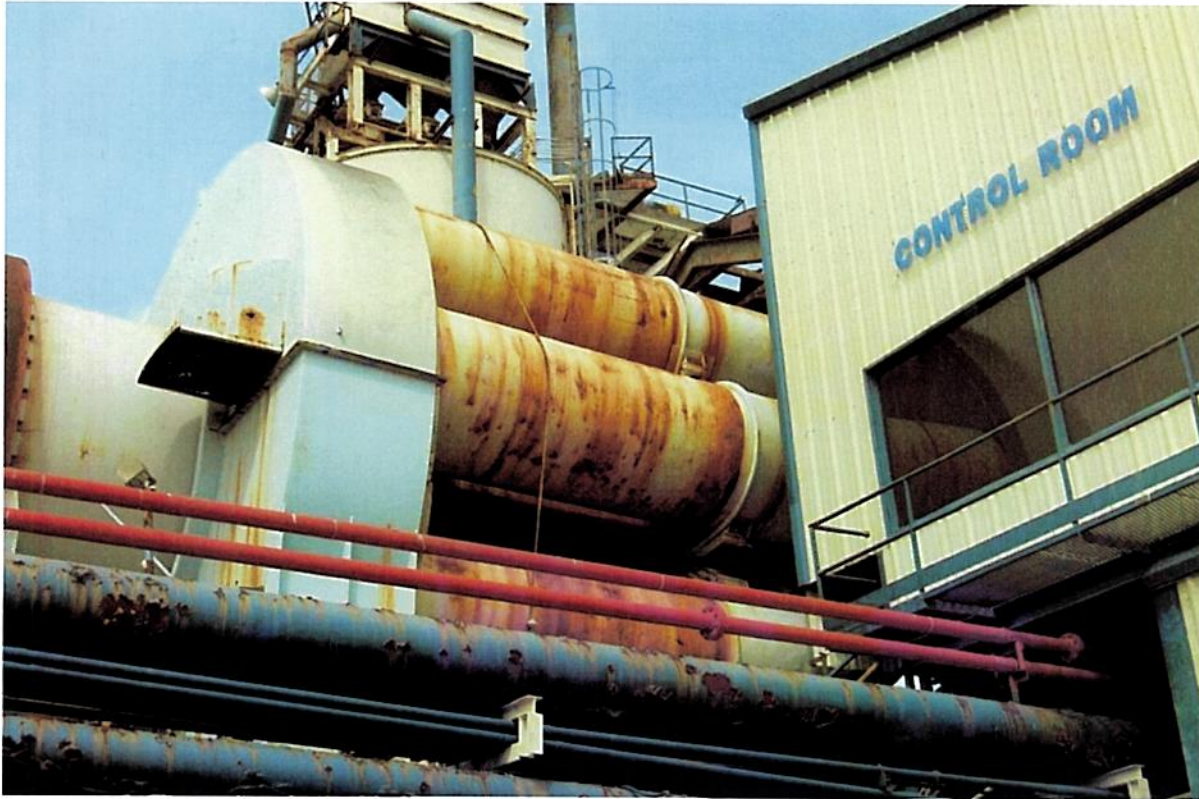
Photographer: C Barnes	Date: 4-30-09	Time: 0900 to 1300
City/County: Amelia,		State: LA
Location: Marine Shale Facility		
Subject: Multiple portions of the facility. Rotary Kiln & Control Room

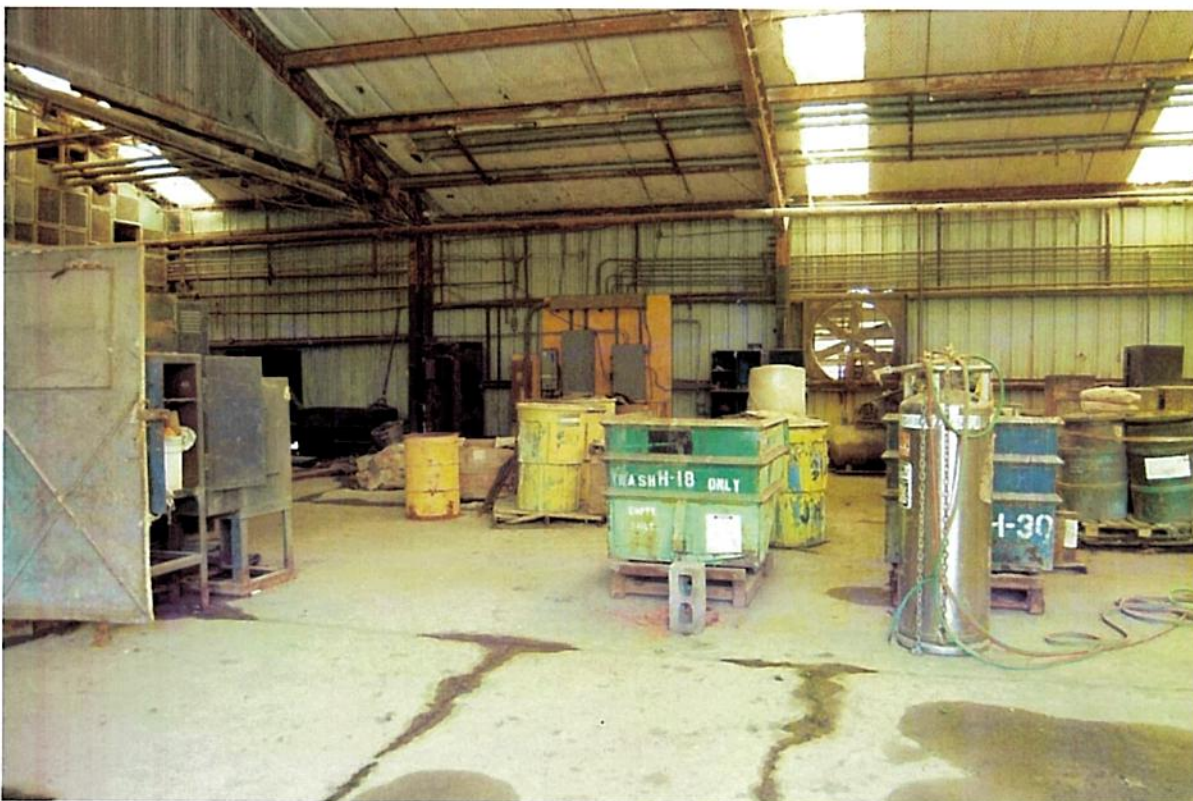
Photographer: C Barnes	Date: 4-30-09	Time: 0900 to 1300
City/County: Amelia,		State: LA
Location: Marine Shale Facility		
Subject: Multiple portions of the facility. Operational Storage Area

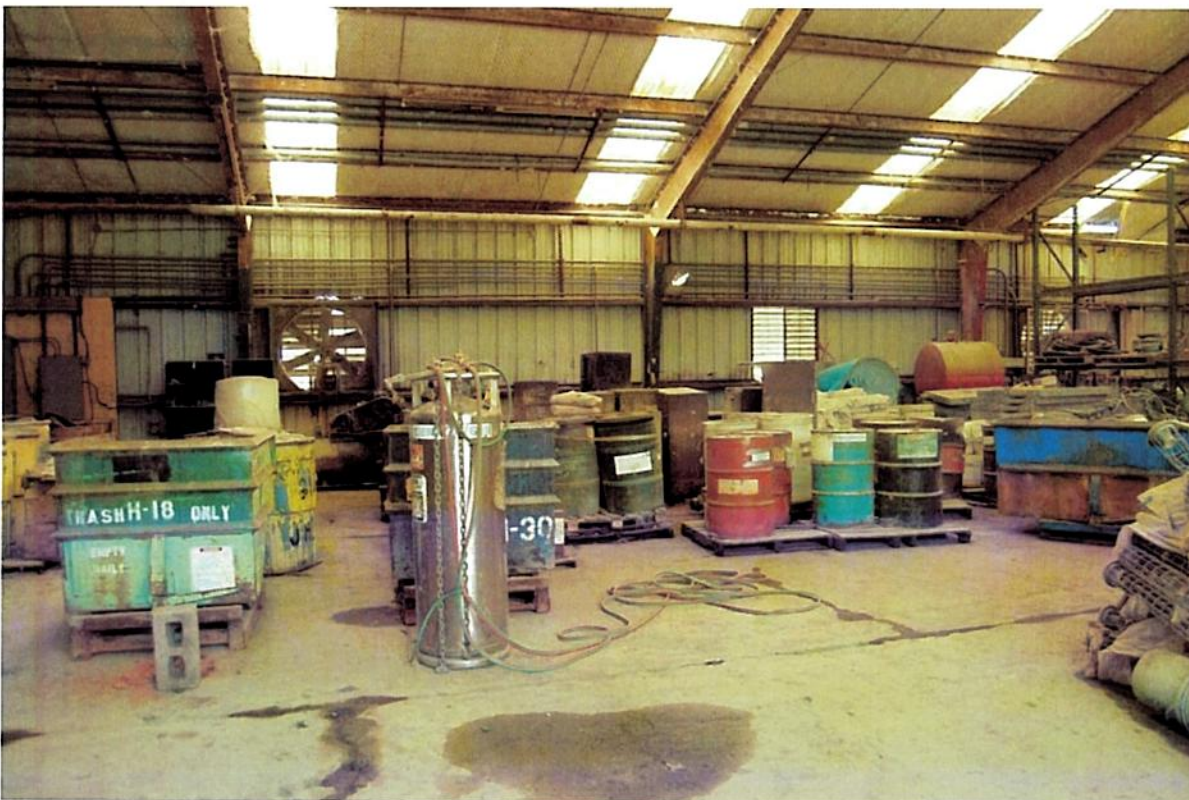
Photographer: C Barnes	Date: 4-30-09	Time: 0900 to 1300
City/County: Amelia,		State: LA
Location: Marine Shale Facility		
Subject: Multiple portions of the facility. Operational Storage Area

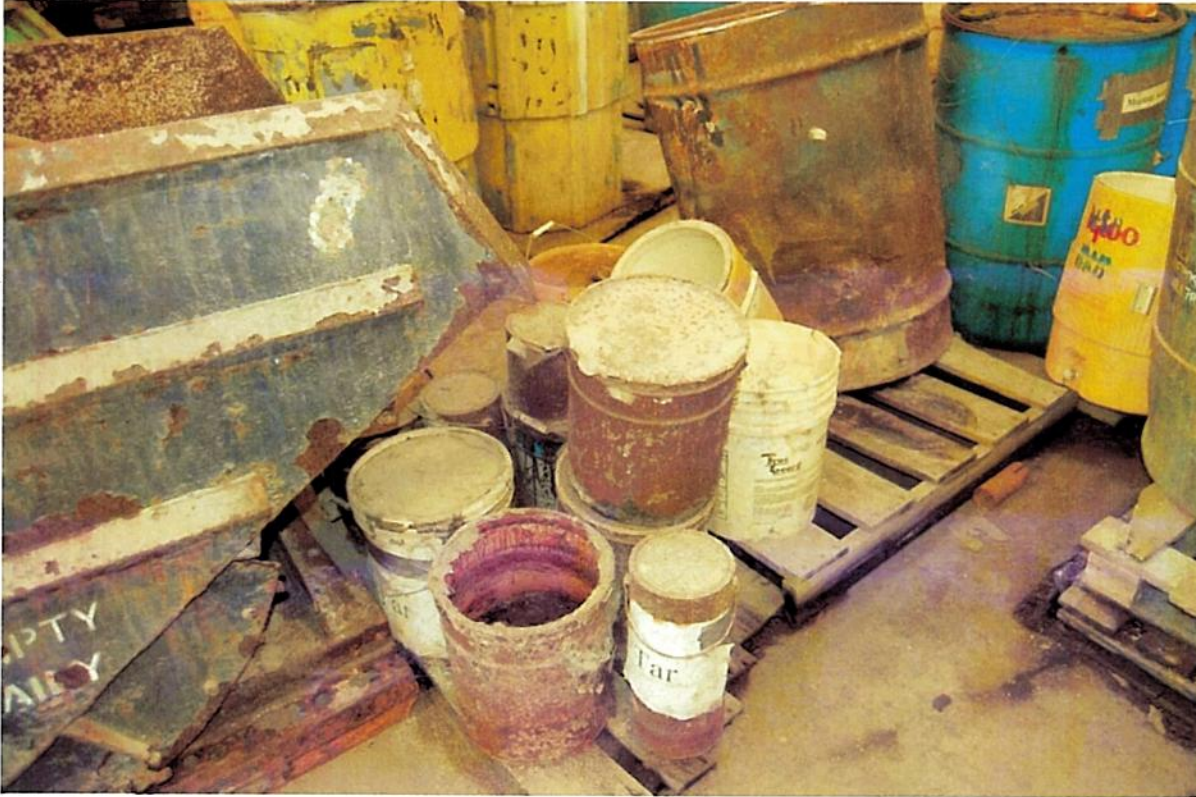
Photographer: C Barnes	Date: 4-30-09	Time: 0900 to 1300
City/County: Amelia,		State: LA
Location: Marine Shale Facility		
Subject: Multiple portions of the facility. Wastes stored in Operational Storage Area

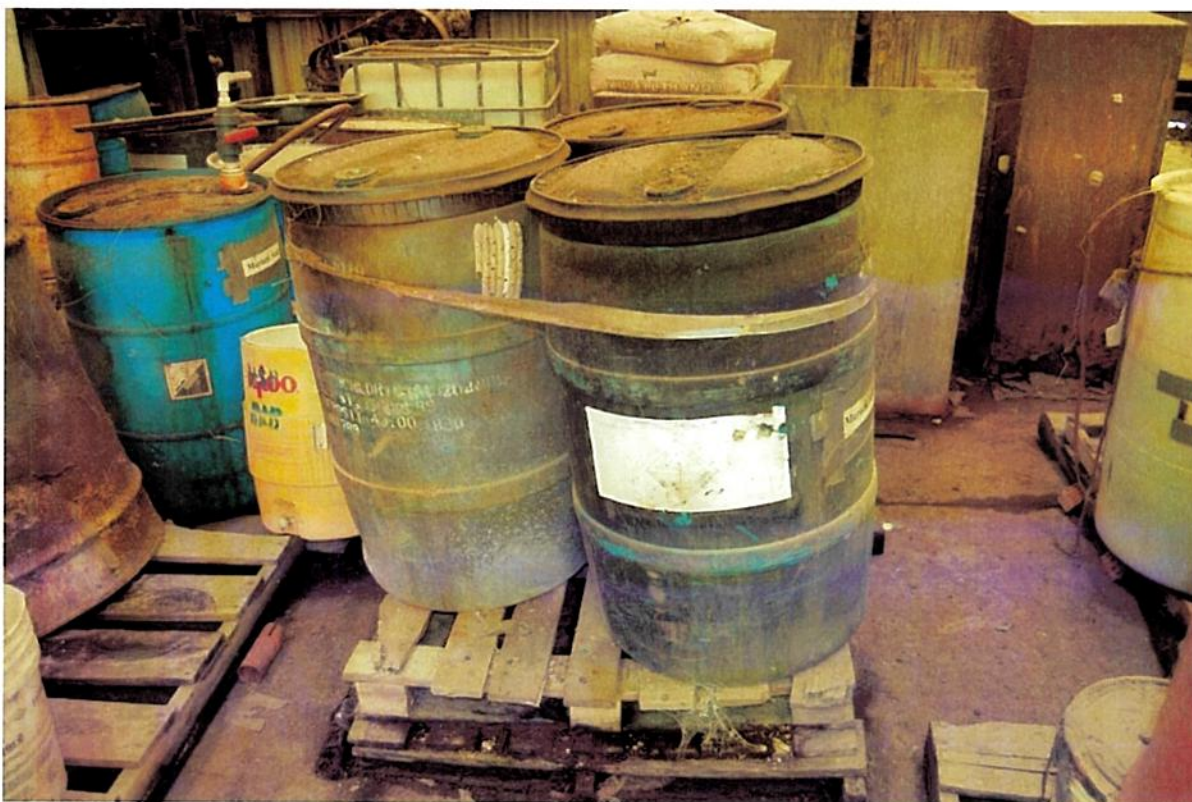
Photographer: C Barnes	Date: 4-30-09	Time: 0900 to 1300
City/County: Amelia,		State: LA
Location: Marine Shale Facility		
Subject: Multiple portions of the facility. Wastes stored in Operational Storage Area

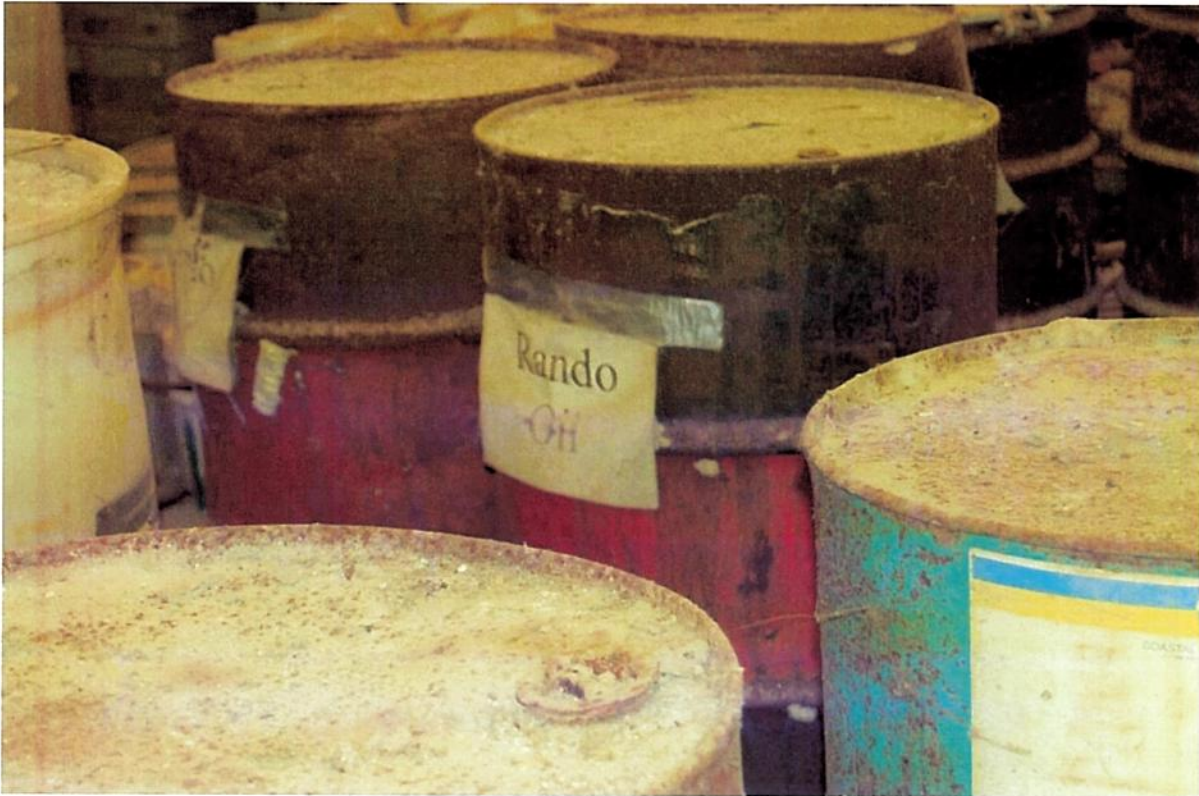
Photographer: C Barnes	Date: 4-30-09	Time: 0900 to 1300
City/County: Amelia,		State: LA
Location: Marine Shale Facility		
Subject: Multiple portions of the facility. Unknown/Unexplained labeling on Drums in Operational Storage Area

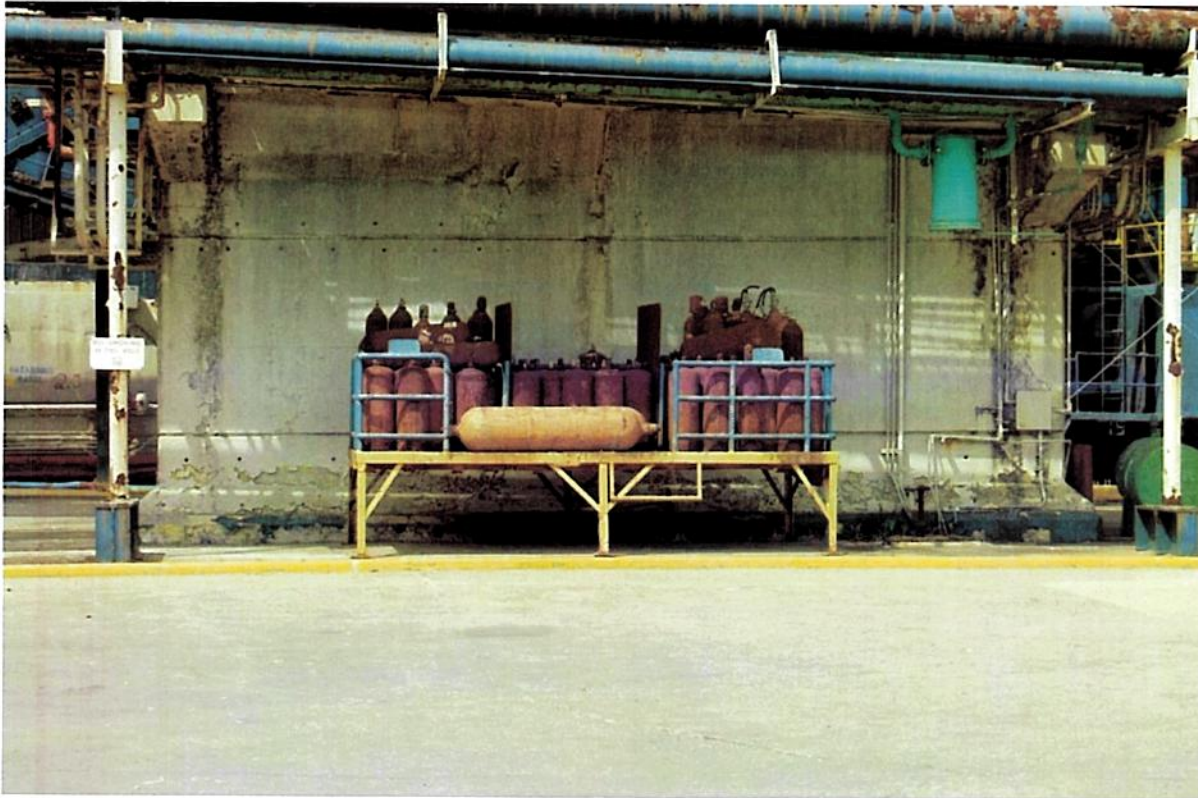
Photographer: C Barnes	Date: 4-30-09	Time: 0900 to 1300
City/County: Amelia,		State: LA
Location: Marine Shale Facility		
Subject: Multiple portions of the facility. Pressurized container storage rack – materials in very poor condition. Contents undetermined.
